INTRODUCTION

ASH DEVELOPMENT ASSOCIATION OF AUSTRALIA
GPO Box 5257, SYDNEY, 2001 AUSTRALIA

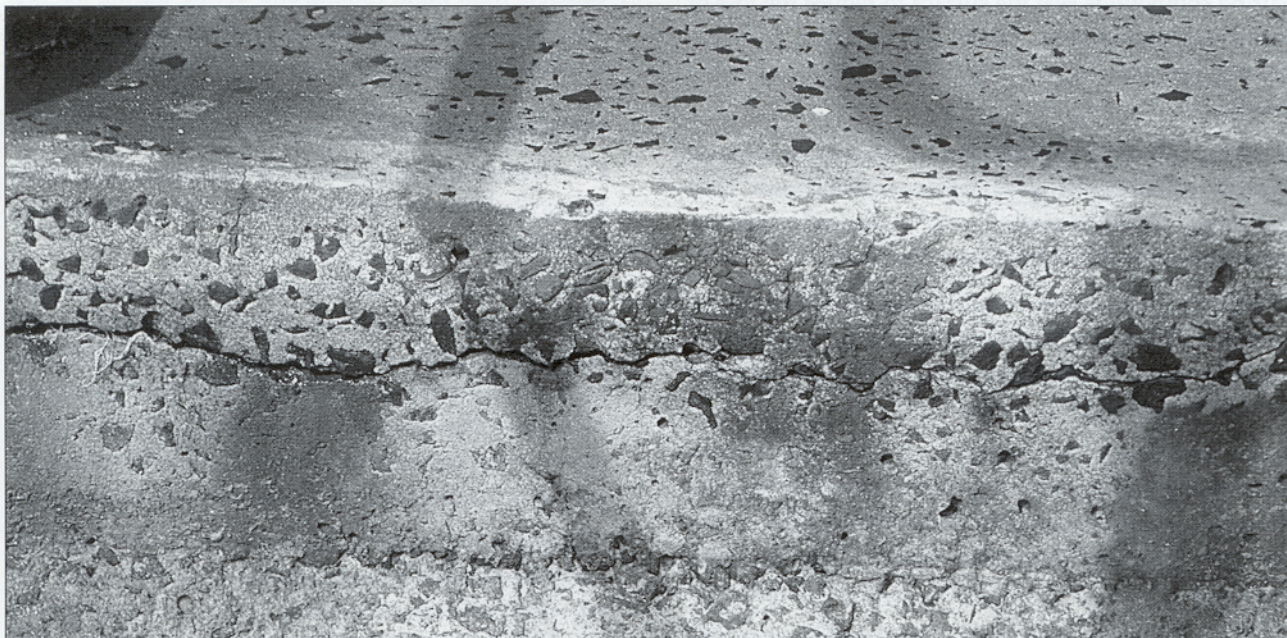
Photograph of saw cut concrete slab edge which includes a significant crack.
